STRUCTURES REPORT 422

CARBON FIBRE COMPOSITE COUPONS -
STATIC AND FATIGUE BEHAVIOUR AFTER IMPACT DAMAGE

G. CLARK and T.J. VAN BLARICUM

AUGUST 1986

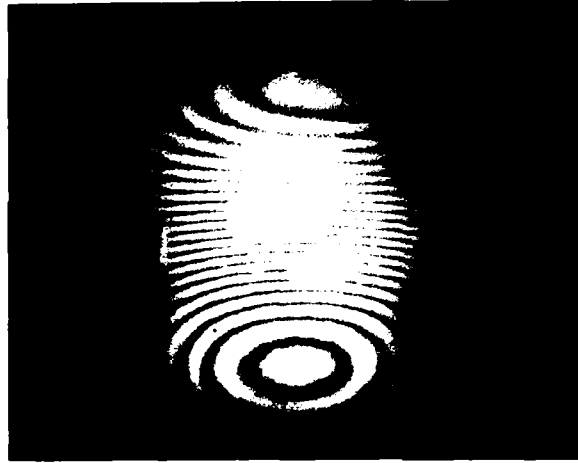
Fig. 13. Shadow Moire representation of the buckling of an inadequately restrained undamaged 24-ply coupon undergoing static compression testing.
